## Inspection Report

### **INSPECTION HOME SERVICES INC.**

<b>Date:</b> 05/25/2007	<b>Time:</b> 8:45 AM	<b>Report ID:</b>
Property:	Customer:	Real Estate Professional:

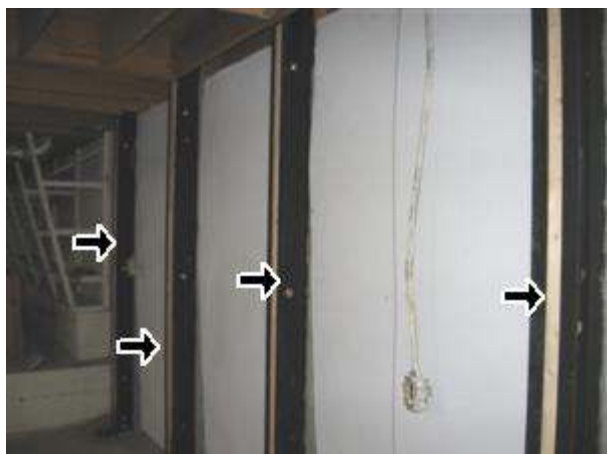
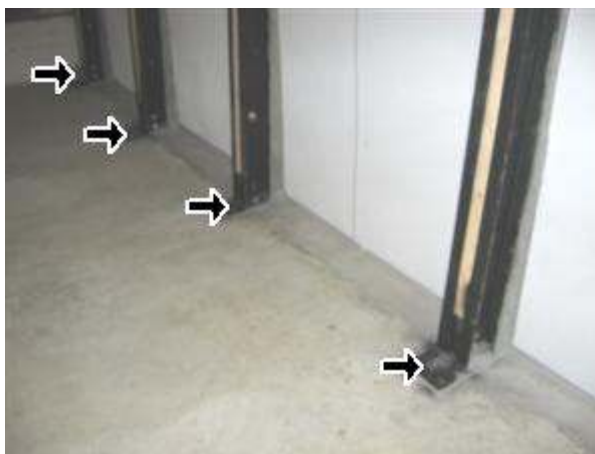
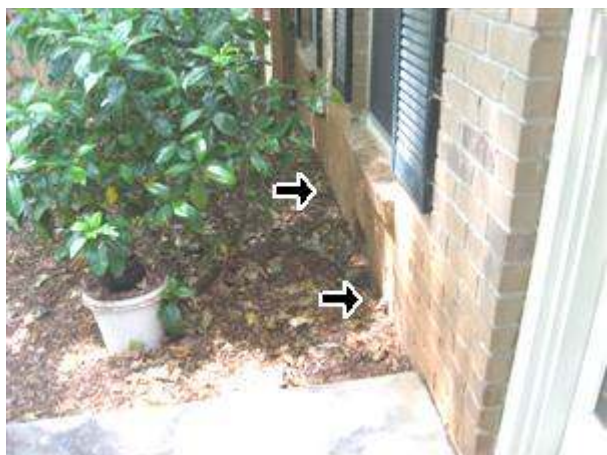
**1.1** Structural repairs were added at front wall of this basement ( Picture 1-2 ) . Note as viewed from front exterior movement of this wall or brick veneer had occurred prior to this repair ( Picture 3 ) . Structure appears to have been repaired in a professional manor. Consult owner for warranty and copy engineers report for repairs made.

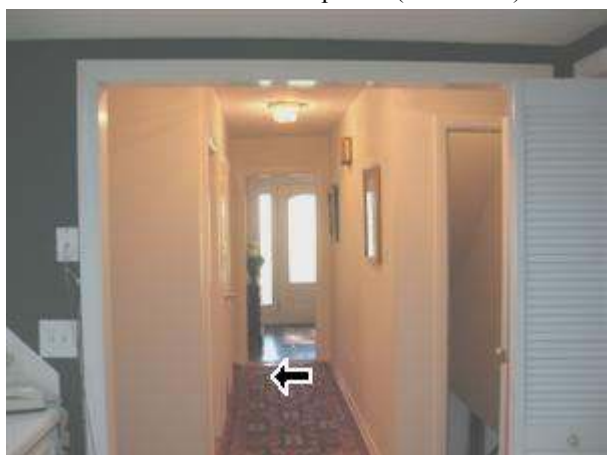
1.5 Picture 1

**1.5** Deflection observed at main level hallway floor ( Picture 1 ) . I would recommend a jack posts be added this area as observed from basement two places ( Picture 2 ) .

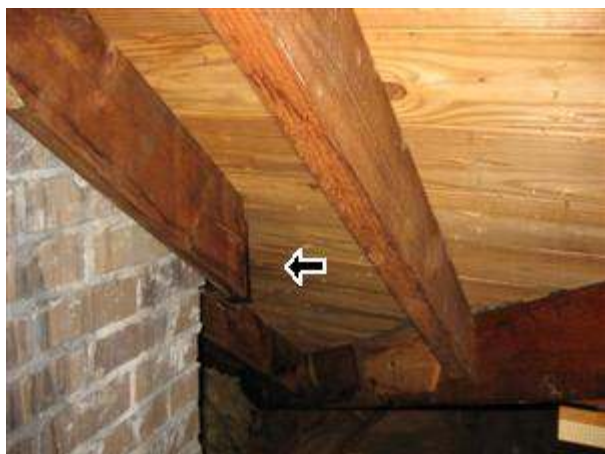
1.7 Picture 1

**1.7** Information note only : Rafter next to chimney as observed from garage attic not connected to valley rafter or headed off to adjoining rafter. There is no indication of structure problem at this time and I would suspect this condition has existed since the house was new.

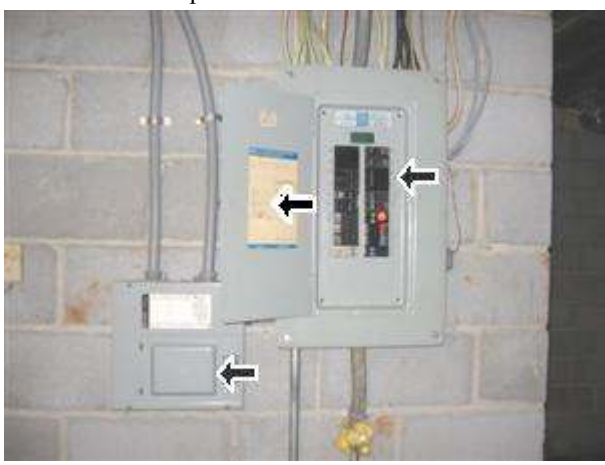
2.1 Picture 1

2.1 Main and sub panel electrical circuits were not labeled. Recommend labeling of circuits as desired for safety

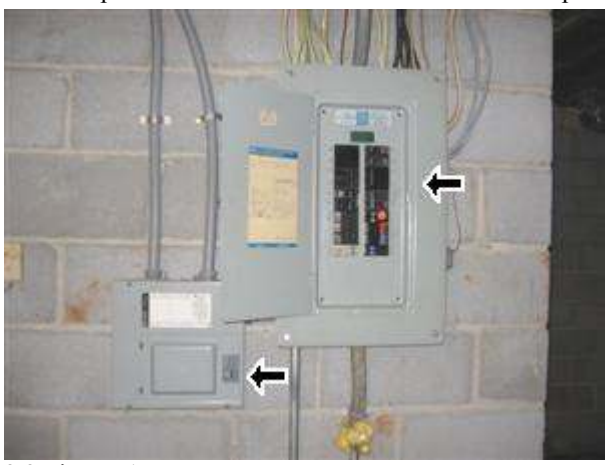
2.2 Picture 1

2.2 Main panel box is located at basement. Note sub panel installed next to main panel.

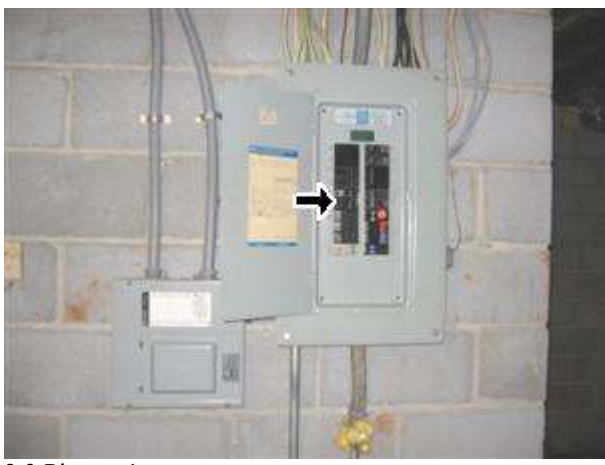
2.3 Main electrical service disconnect is located inside main panel box

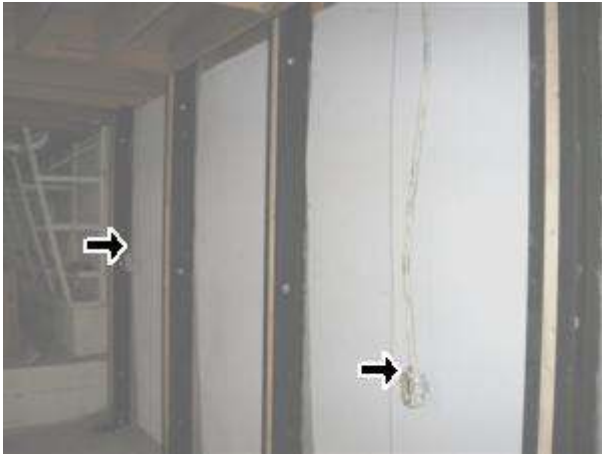
2.8 Picture 1

2.8 1. Loose electrical outlets (not attached) front wall of basement ( Picture 1 ) . Appears work was performed (water

proofing and structural support added) this area and work was not completed for re-installation of these outlets to the wall. Secure as needed.

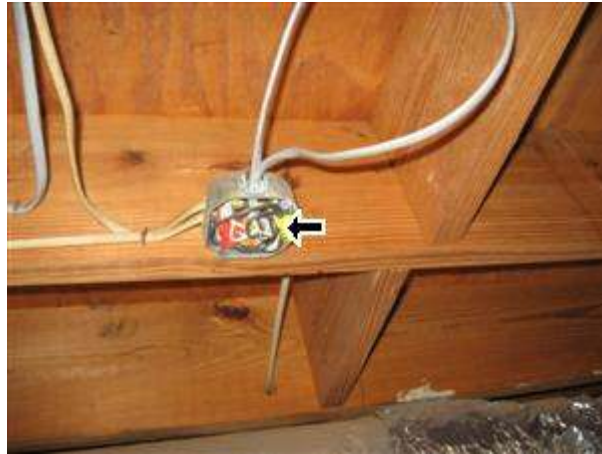
2.8 Picture 2

2. Missing junction box cover observed basement ceiling area ( Picture 2 ) . Install cover.

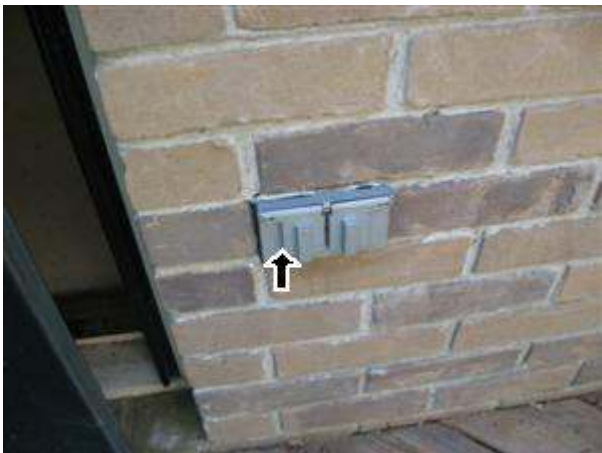
2.10 Picture 1

**2.10** 1. Rear deck electrical outlet appears loose. Secure this outlet. Note I would recommend converting this outlet (upgrade) to a GFCI (Ground Fault Control Interrupt) type).

2. Note garage electrical outlet is not GFCI (Ground Fault Control Interrupt) protected you may wish to upgrade to a GFCI type.

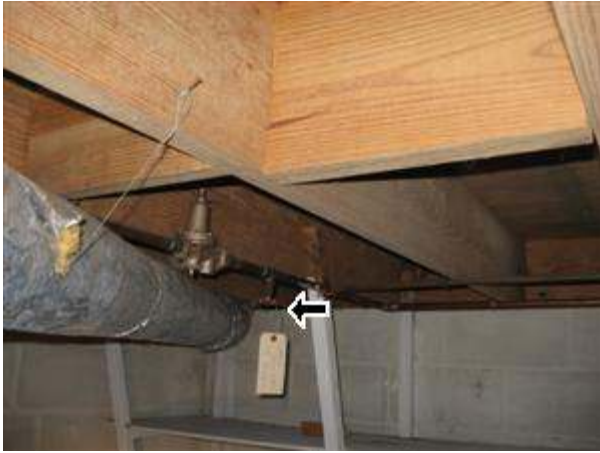
4.0 Picture 1

**4.0** The main shut off is the red knob located in basement forward area (marked). This is for your information.

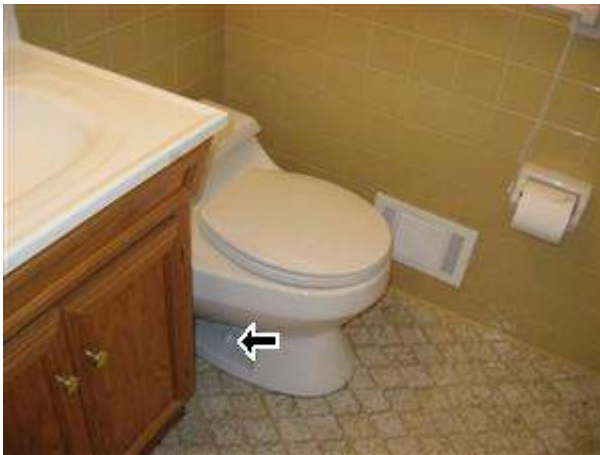
4.1 Picture 1

4.1 Main level hall bathroom commode appears not to be secured to flange properly (loose). Secure as needed to prevent leakage at wax seal.

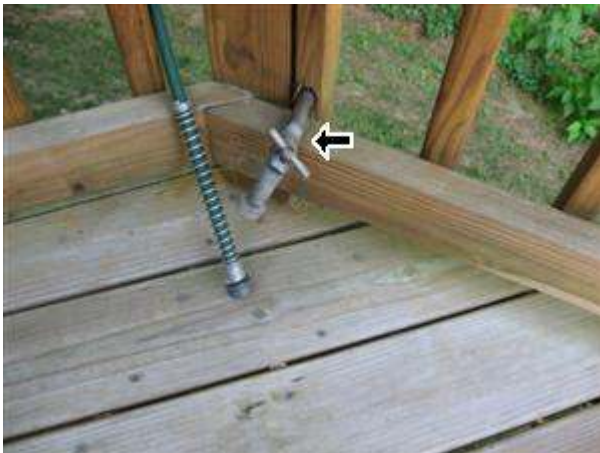
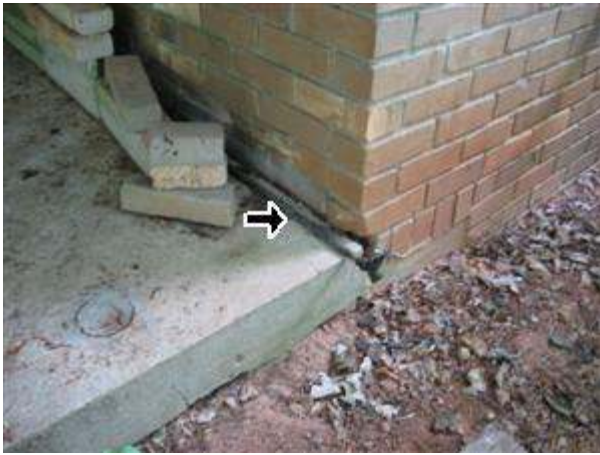
4.2 Rear deck exterior faucet that was added appears to be winterized at this time. Potential for this pipe to freeze during the winter (not tested). Consult owner.

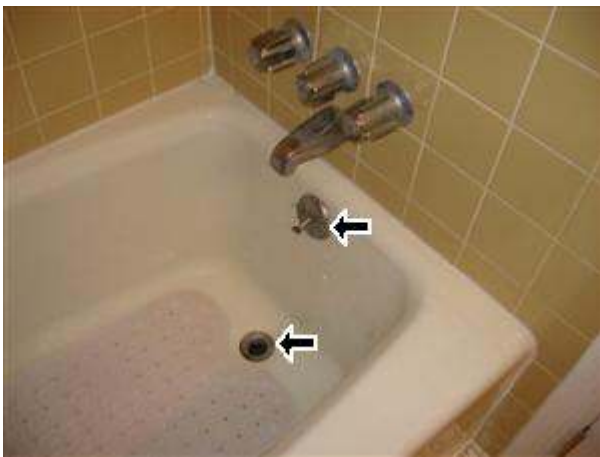
4.3 Picture 1

4.3 Information note main level hall bathroom bath tub drain stop is non functional at this time (not uncommon to see on older homes) Repair as desired.

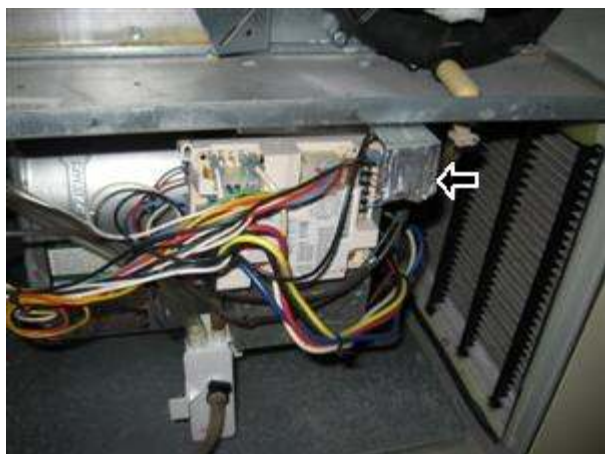
5.3 Picture 1

5.3 Information note only : Fan compartment door safety switch taped over. Unit service switch was observed on the side of this unit and was working normal.

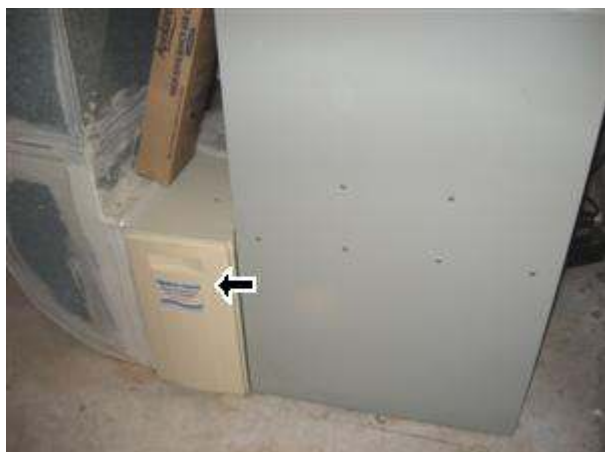
5.4 Picture 1

5.4 Filter located at furnace in basement mounted of back side of system ( Picture 1 ) .

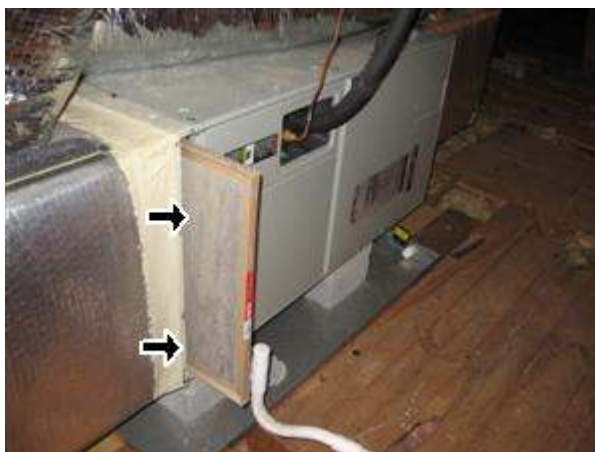
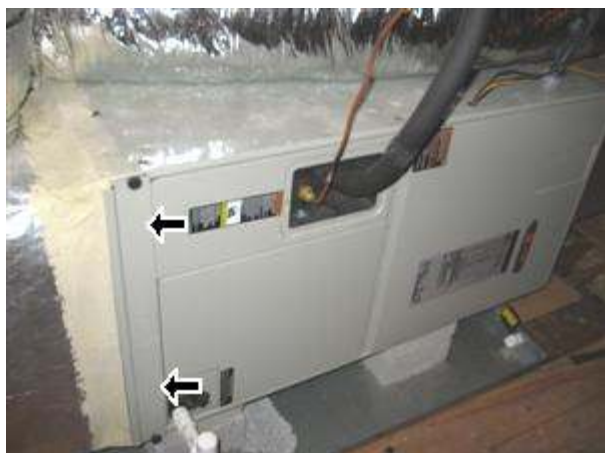
Note filter installed at return end of unit in attic is very dirty and needs to be replace ( Picture 2-3 ) .

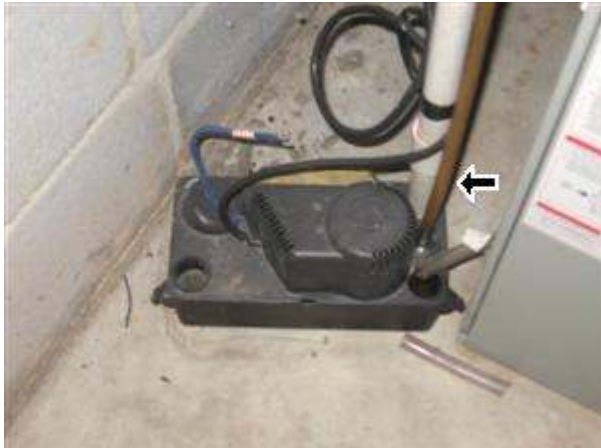
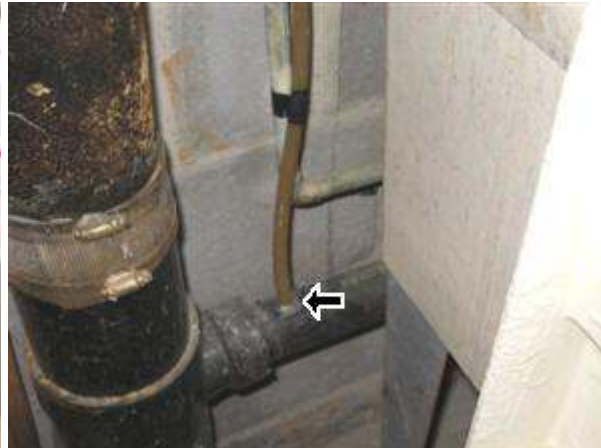
**6.1** Note AC condensate drain line now installed to plumbing waste drain as observed next to basement laundry sink, this is not recommended. I recommend this drain be corrected and extended to exterior of house.

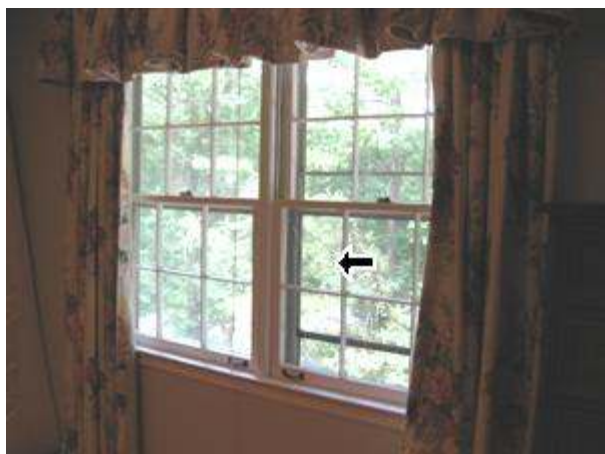
7.4 Picture 1

2. Cracked window pane rear left corner bedroom window ( Picture 1 ) . Replace pane of glass.

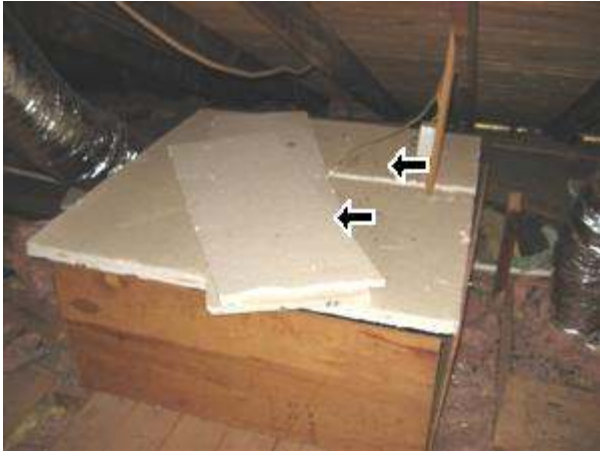
8.4 Picture 1

**8.4** Information note Insulation board laying on top of whole house fan as observed in attic area. Remove prior to use of this fan.

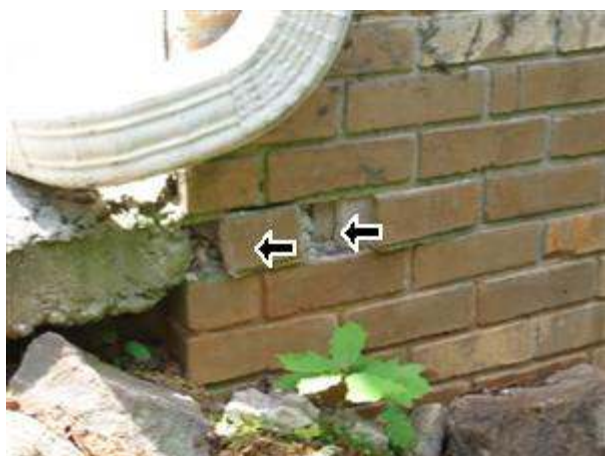
9.2 Picture 1

9.2 Note loose brick veneer at front corner of garage.

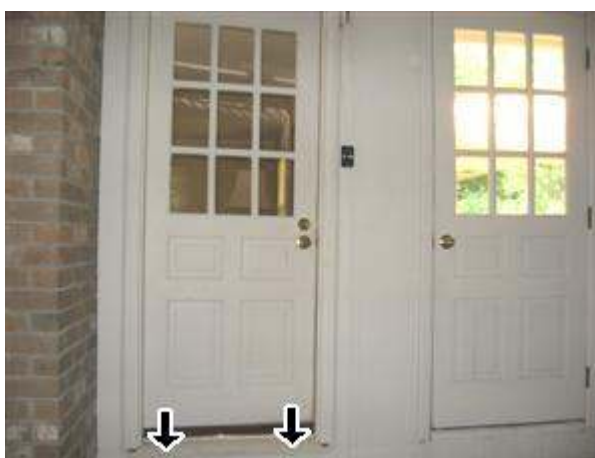
9.4 1. Garage entry door threshold from garage into house is split (damaged) and should be replaced ( Picture 1-2 ) .  
Replace / repair.

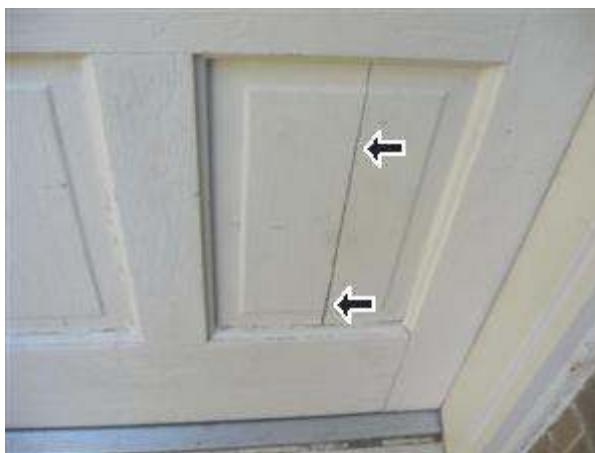
2. Exterior door from garage to deck has split panel ( Picture 3-4 ) . Seal crack and paint.

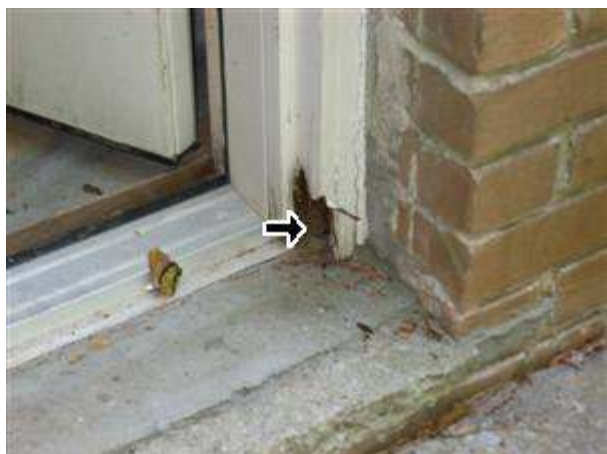
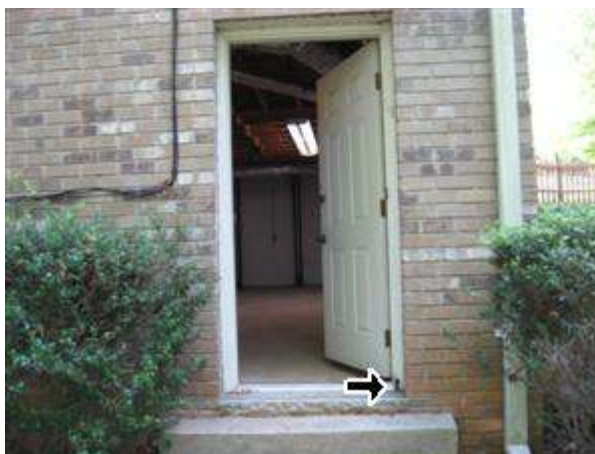
3. Wood rot rear entry door jamb to basement ( Picture 5-6 ) . Repair.

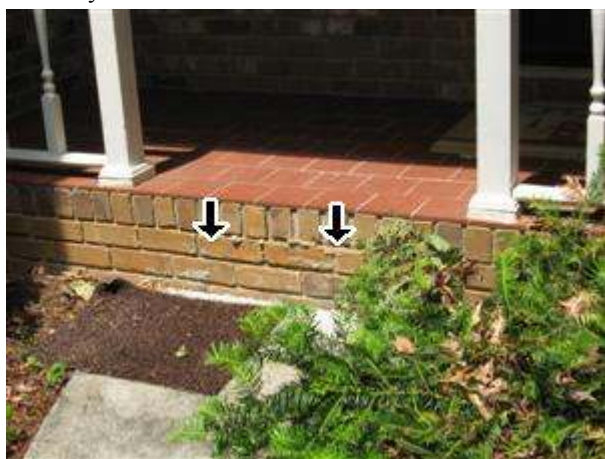
9.7 Picture 1

9.7 Excessive height from walkway to small porch area at front of house ( Picture 1 ) . Recommend addition of step this area for safety.

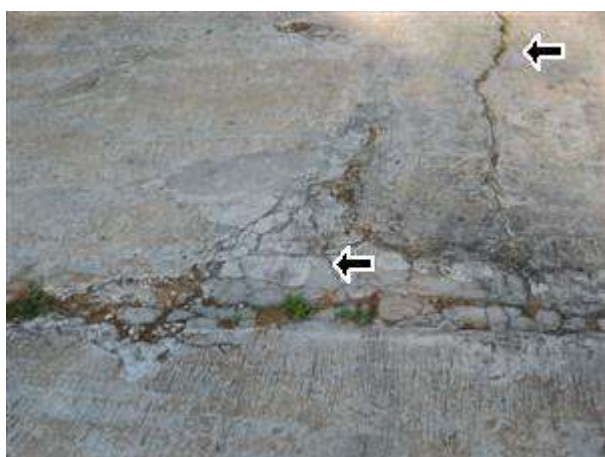
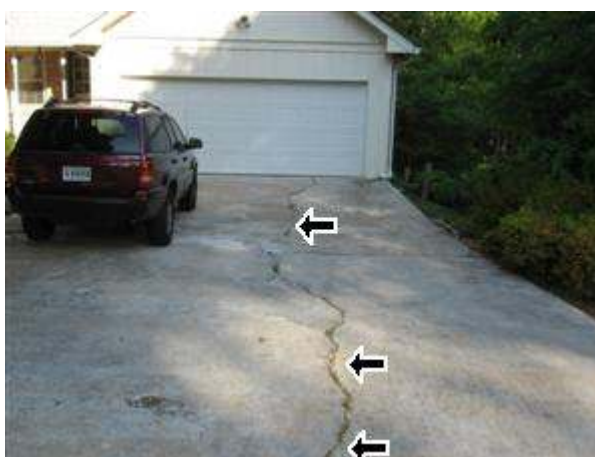
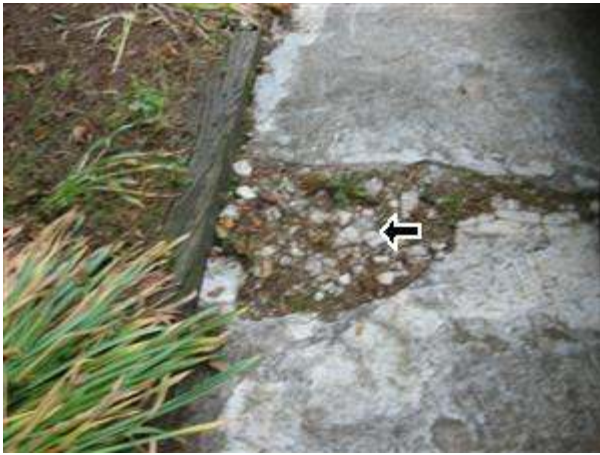
9.9 Note cracked broken areas were observed in this driveway with only minor settlement observed. Monitor and patch and seal as desired.

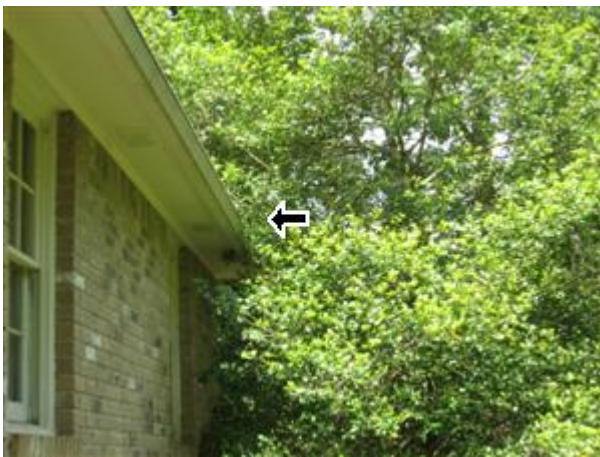
9.10 Picture 1

9.10 Tree limbs against side roof area of garage. Trim trees (shrubs) close to house at right side .Monitor trees at front of house and trim when needed.

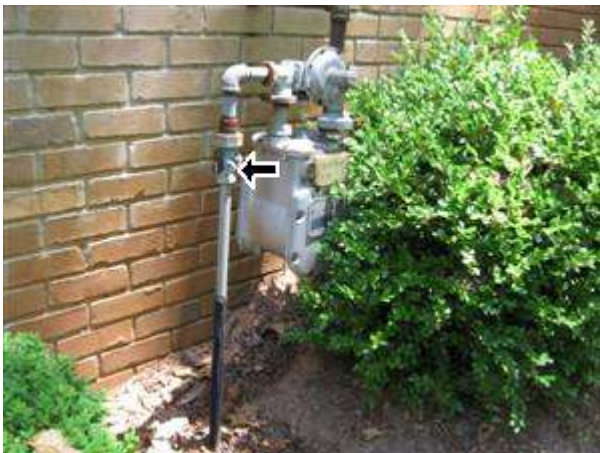
9.12 Picture 1

9.12 The main gas shut off is located outside at meter left side (facing front). This is for your information.

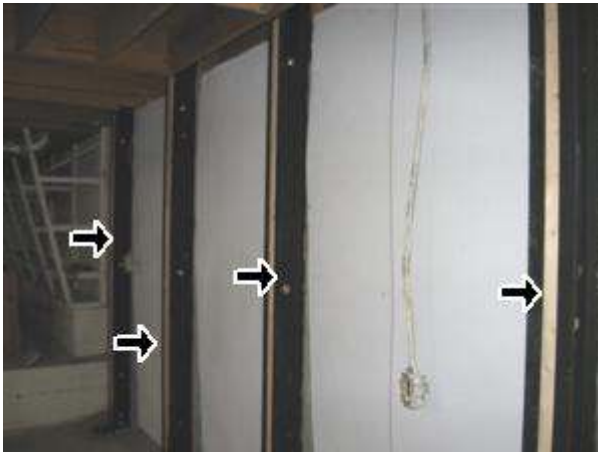
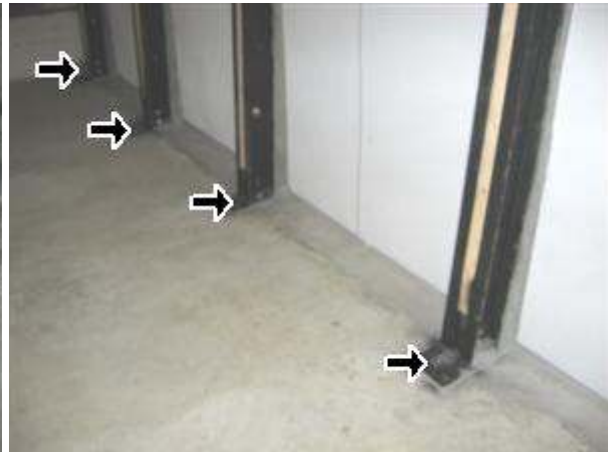
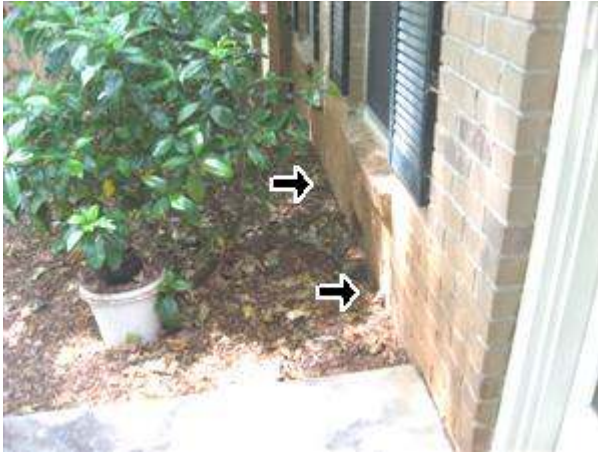
Structural repairs were added at front wall of this basement ( Picture 1-2 ). Note as viewed from front exterior movement of this wall or brick veneer had occurred prior to this repair ( Picture 3 ). Structure appears to have been repaired in a professional manor. Consult owner for warranty and copy engineers report for repairs made.

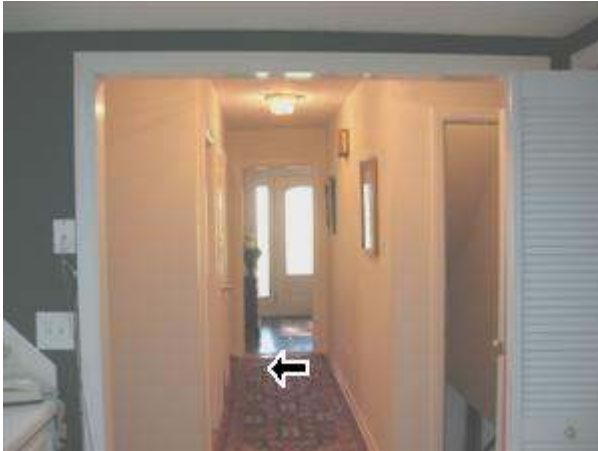
1.5 Picture 1

Deflection observed at main level hallway floor ( Picture 1 ) . I would recommend a jack posts be added this area as observed from basement two places ( Picture 2 ) .

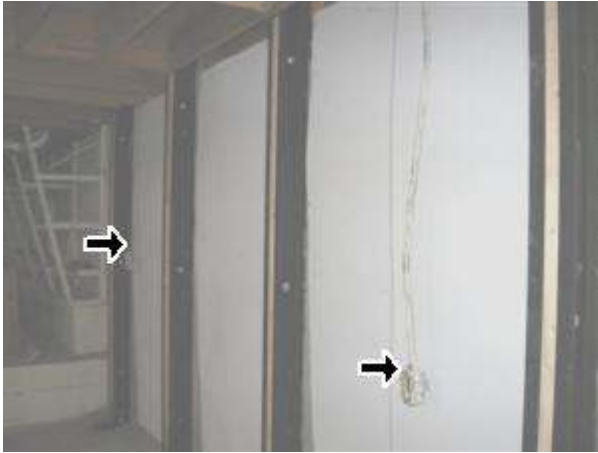
2.8 Picture 1

1. Loose electrical outlets (not attached) front wall of basement ( Picture 1 ) . Appears work was performed (water proofing and structural support added) this area and work was not completed for re-installation of these outlets to the wall. Secure as needed.

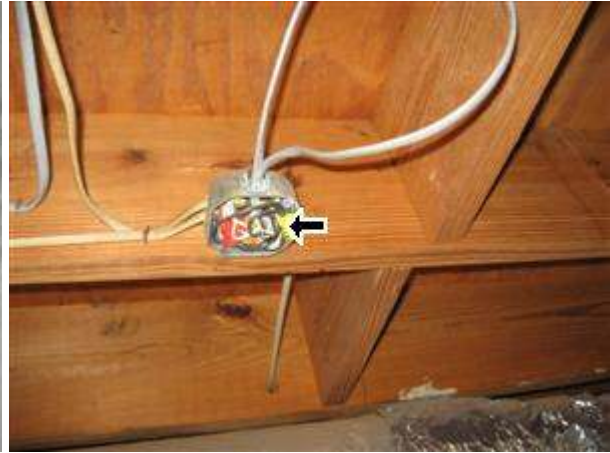
2.8 Picture 2

2. Missing junction box cover observed basement ceiling area ( Picture 2 ) . Install cover.

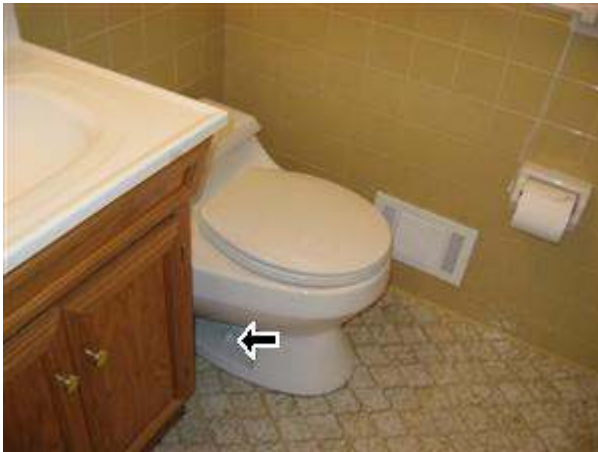
4.1 Picture 1

Main level hall bathroom commode appears not to be secured to flange properly (loose). Secure as needed to prevent leakage at wax seal.

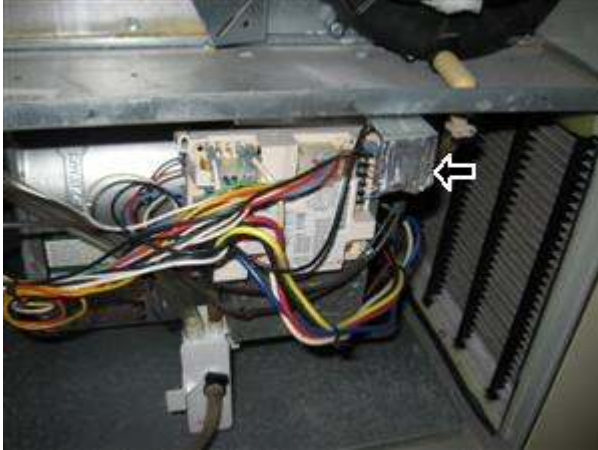
5.3 Picture 1

Information note only : Fan compartment door safety switch taped over. Unit service switch was

observed on the side of this unit and was working normal.

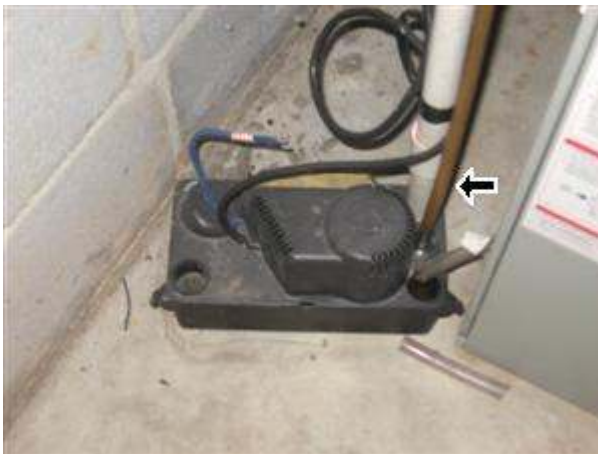
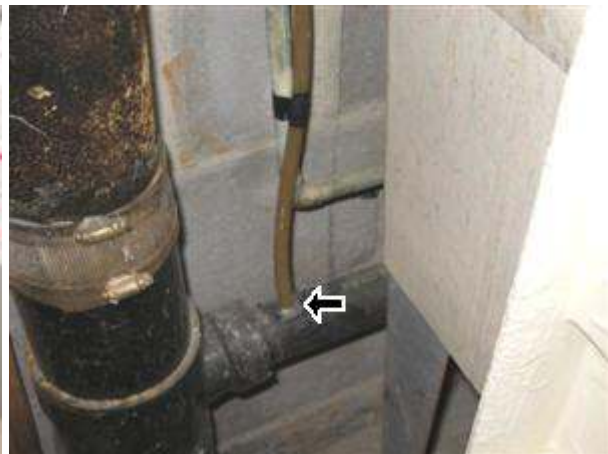
Note AC condensate drain line now installed to plumbing waste drain as observed next to basement laundry sink, this is not recommended. I recommend this drain be corrected and extended to exterior of house.

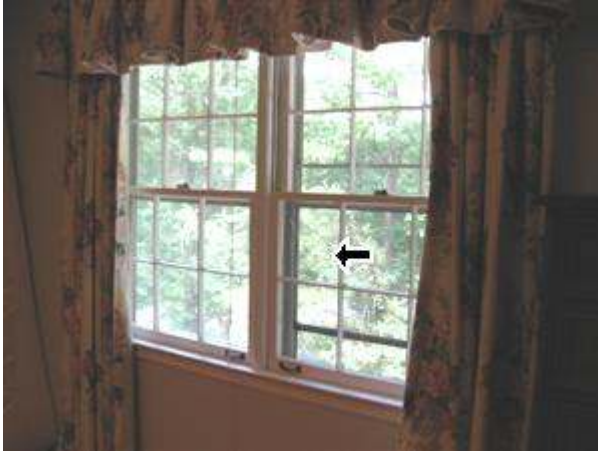
7.4 Picture 1

1. Note a number of windows on main level (with ease of access into house) were screwed shut and were not tested for operation.
2. Cracked window pane rear left corner bedroom window ( Picture 1 ) . Replace pane of glass.

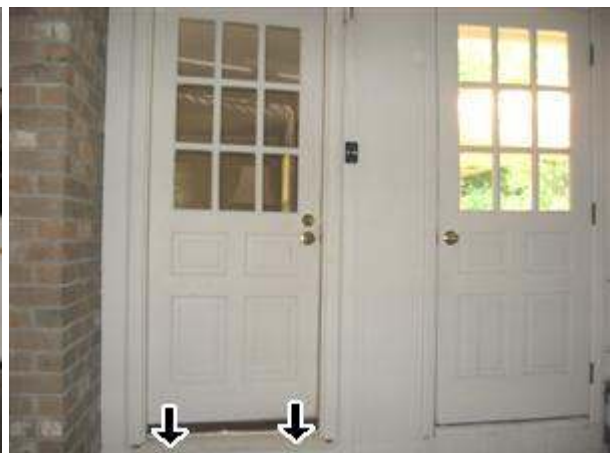
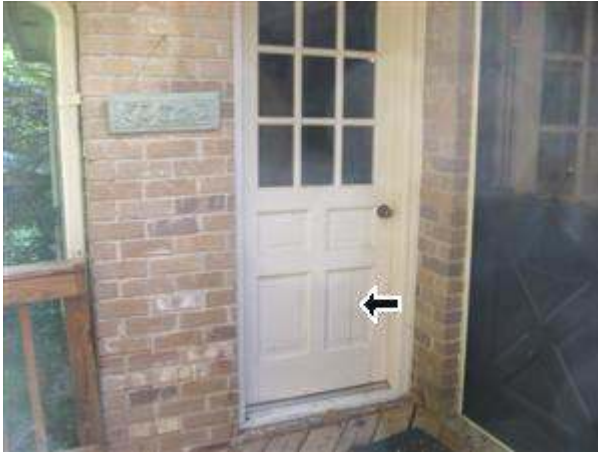
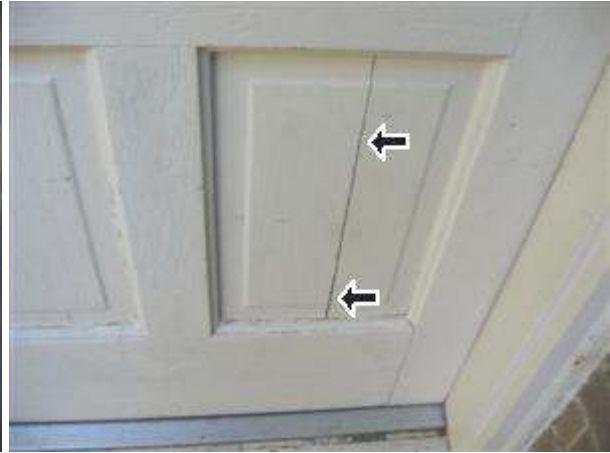
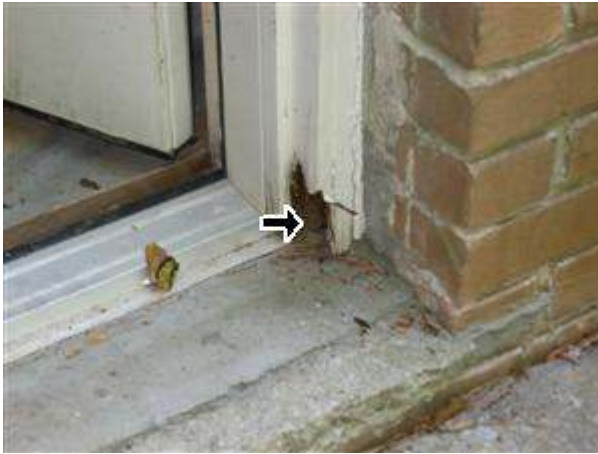
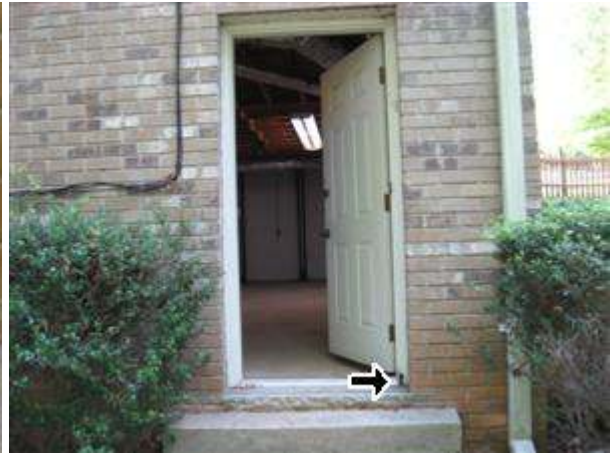
1. Garage entry door threshold from garage into house is split (damaged) and should be replaced ( Picture 1-2 ) . Replace / repair.
2. Exterior door from garage to deck has split panel ( Picture 3-4 ) . Seal crack and paint.
3. Wood rot rear entry door jamb to basement ( Picture 5-6 ) . Repair.

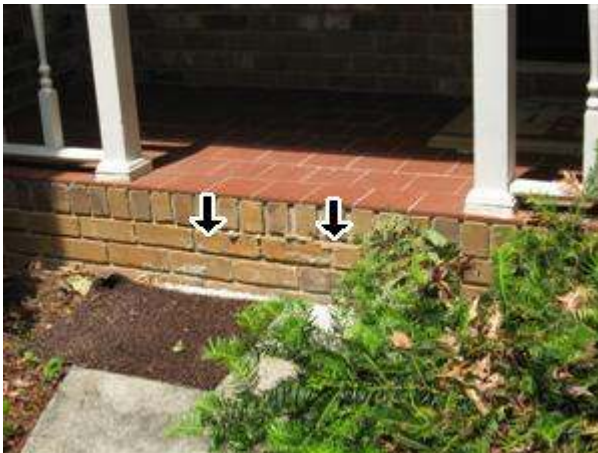
9.7 Picture 1

Excessive height from walkway to small porch area at front of house ( Picture 1 ) . Recommend addition of step this area for safety.

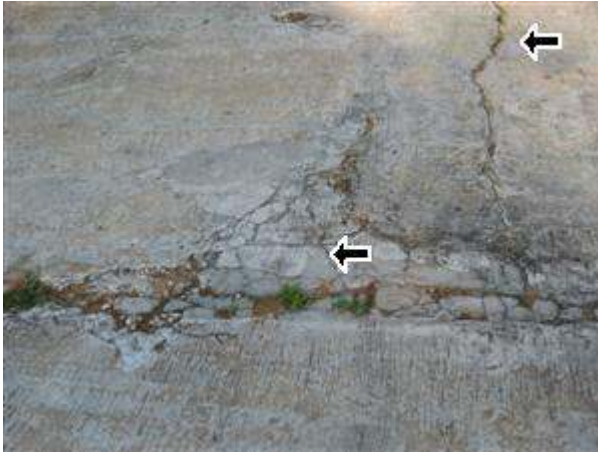
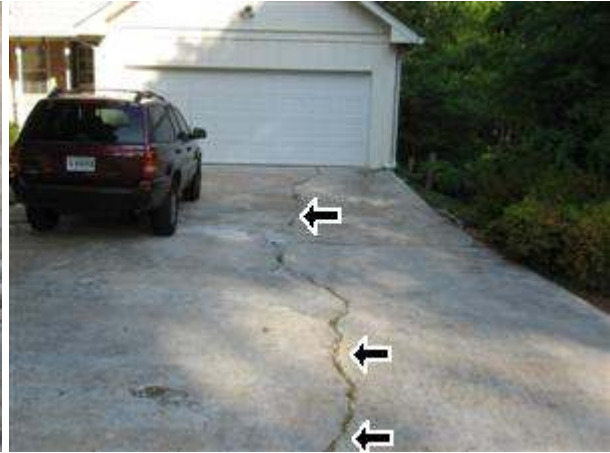
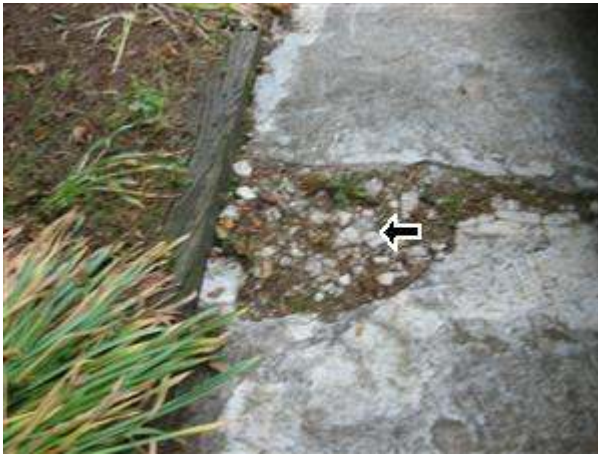
Note cracked broken areas were observed in this driveway with only minor settlement observed. Monitor and patch and seal as desired.
